ANALYSIS OF TUBE FAILURE IN ECONOMIZER AND SUPER HEATER TUBE IN THERMAL POWER STATION

2. ECONOMIZER AND SUPERHEATER TUBE FAILURE ANALYSIS

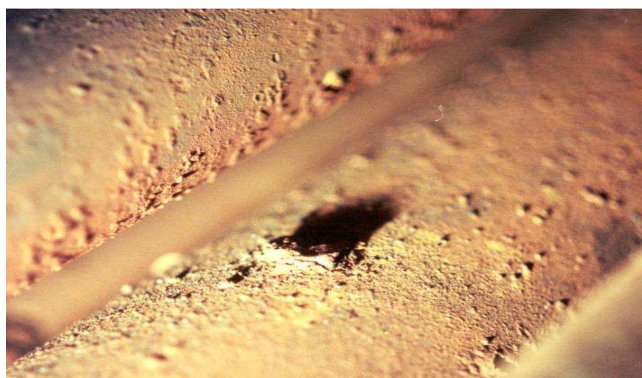
The following are the areas in boiler where coal particle erosion is usually experienced; Economizer bends and water wall tubes, Screen tubes, Goose neck portion at furnace top, Soot blower opening in the water walls, Wind box opening in the furnace, Bottom hopper tubes. Figure 2.1.1 represents the boiler tube erosion due to coal particle.

Figure 2.1.1: Coal Particle Erosion

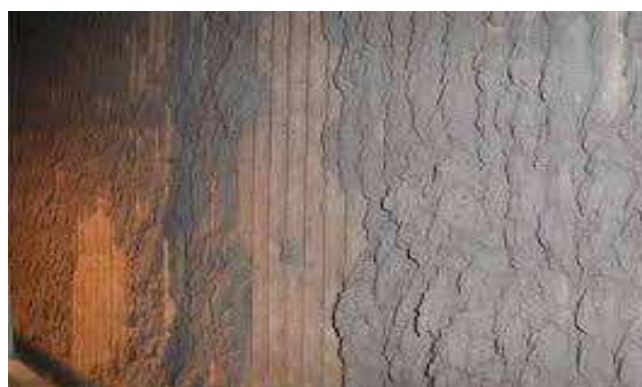
Slag is formed by the reaction of deposited ash particles with the boiler tube material, prolonged traveling of ash particles around boiler tube cause deposition of ash and at high temperature deposit, boiler tube particle reacts to form molten metal slag, this falls on the lower tube and erodes those tubes. Figure 2.1.2 represents the formation of slag around boiler tubes.

Figure 2.1.2: Slag Formed Around Boiler

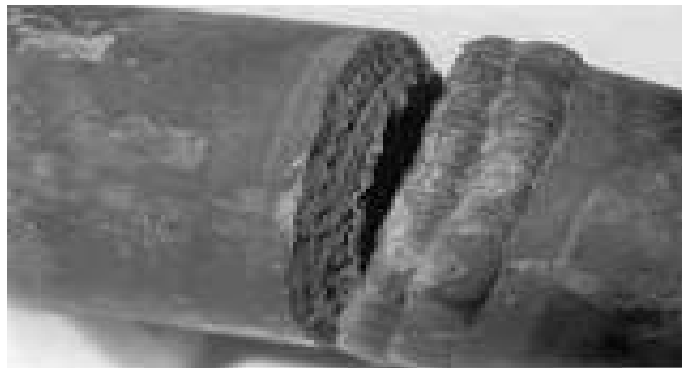
In the Thermal Power Station, dissimilar metal welds are used to join ferrisite low-alloy steels to austenitic stainless steels. Unfortunately, these welds can fail prematurely from accelerated creep. However, a transition joint where the composition changes from austenitic steel to ferrisite steel, could replace then one dissimilar weld with two similar welds. Figure 2.1.3 shows the failure of dissimilar metal welds in boiler tube of a water tube boiler.

Figure 2.1.3: Dissimilar Metal Weld Failure
